**METALLURGICAL EVALUATION AND
FRACTURE ANALYSIS OF A
PNEUMATICALLY-BURST SEAMLESS
STEEL COMPRESSED GAS
CYLINDER**

Bruce W. Christ and John H. Smith

Failure Analysis Report

April, 1977

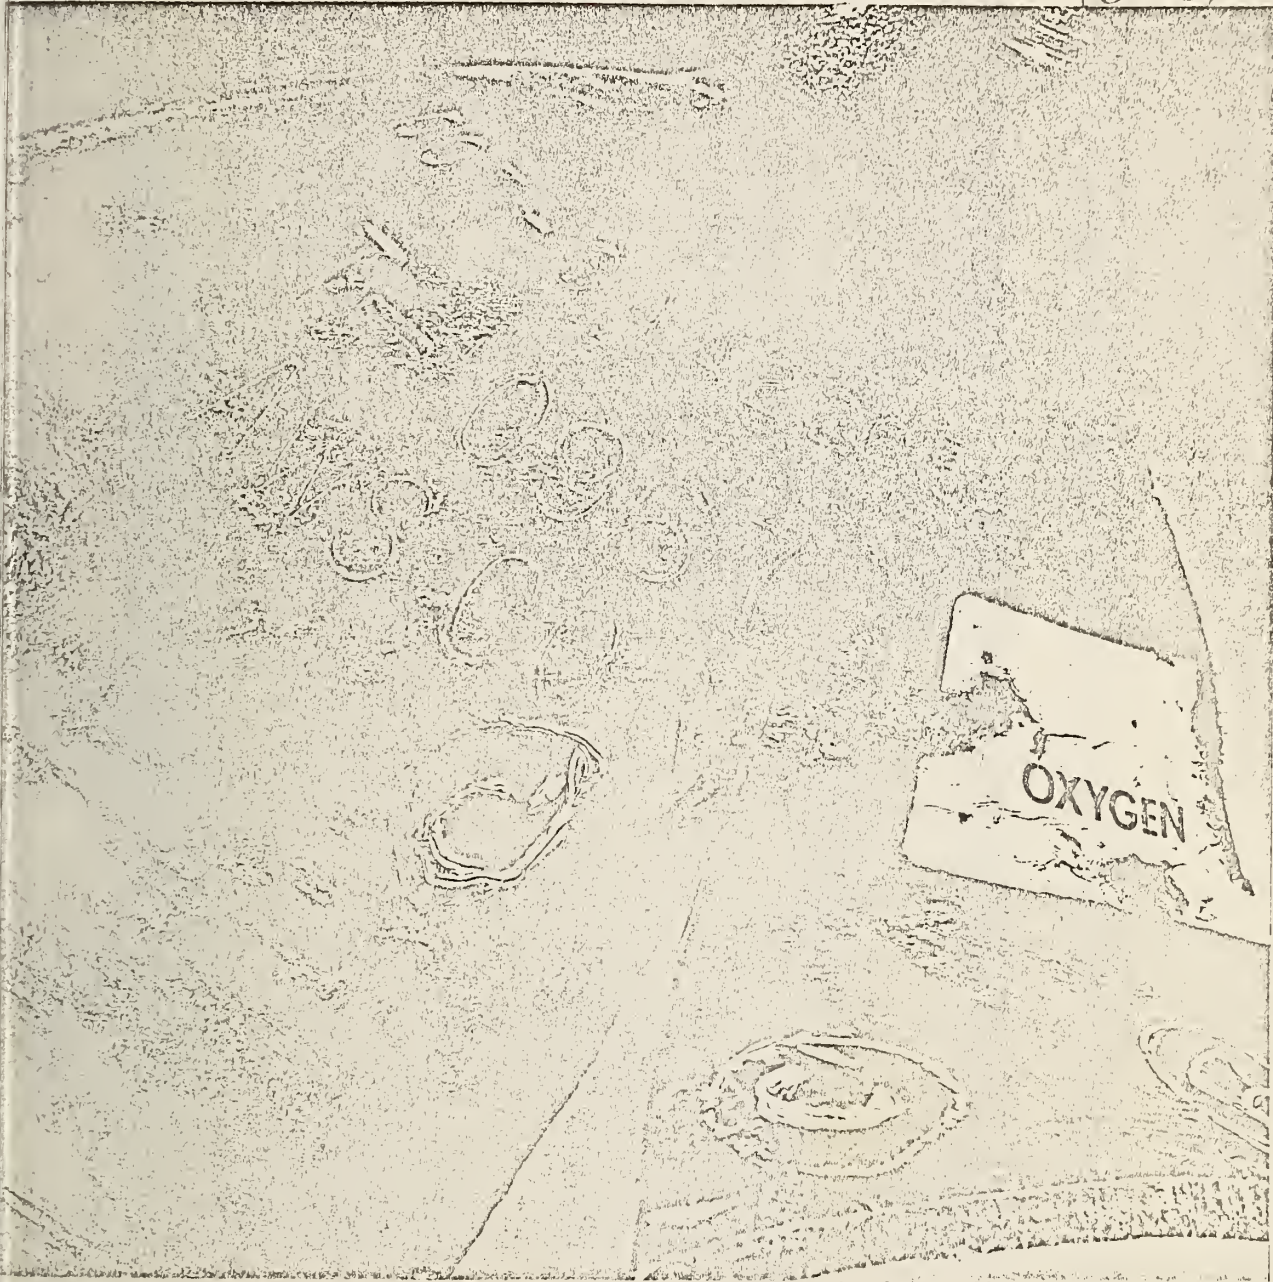
Figure 2a. View of Department of Transportation stampings
on gas cylinder T-0967. Note the crack arrest
in this half of the neck. X 1

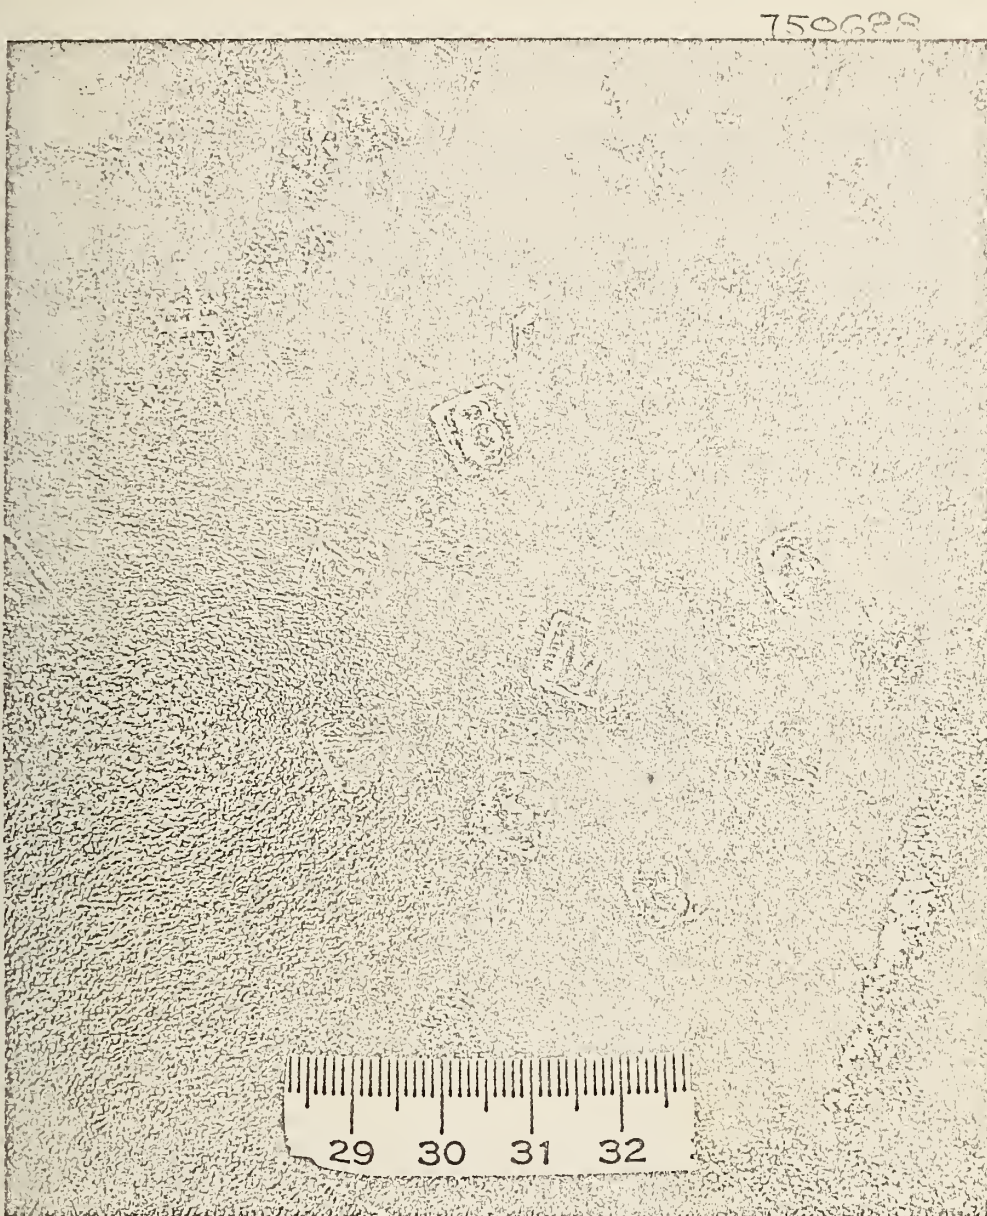
Figure 3. Markings on the bottom of cylinder T-0967,
showing the heat code, V18. X 1

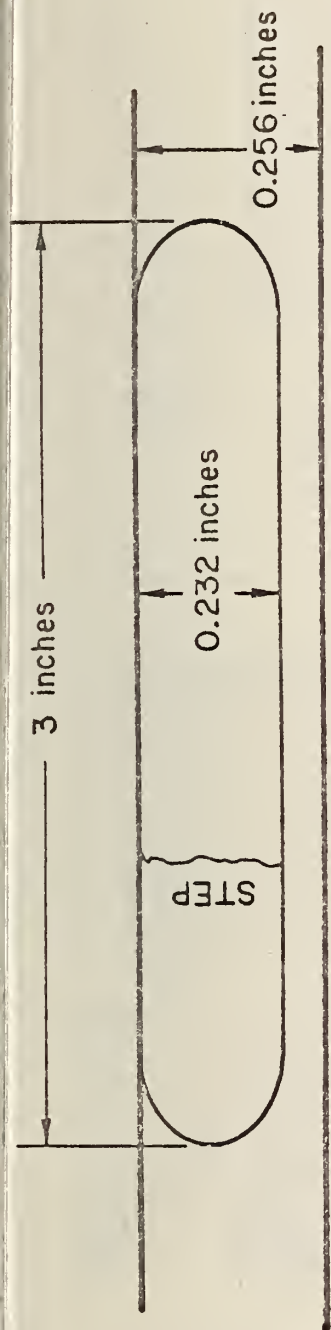
Figure 5 shows the side of the fracture origin labeled a in Figure 1b. The step and highly-reflective band along the inside wall are evident. Dimensions of the fracture origin are shown in the schematic diagram included in Figure 5.

Figure 5. View of the side of the fracture origin labeled a in Figure 1b, with a schematic diagram showing dimensions.

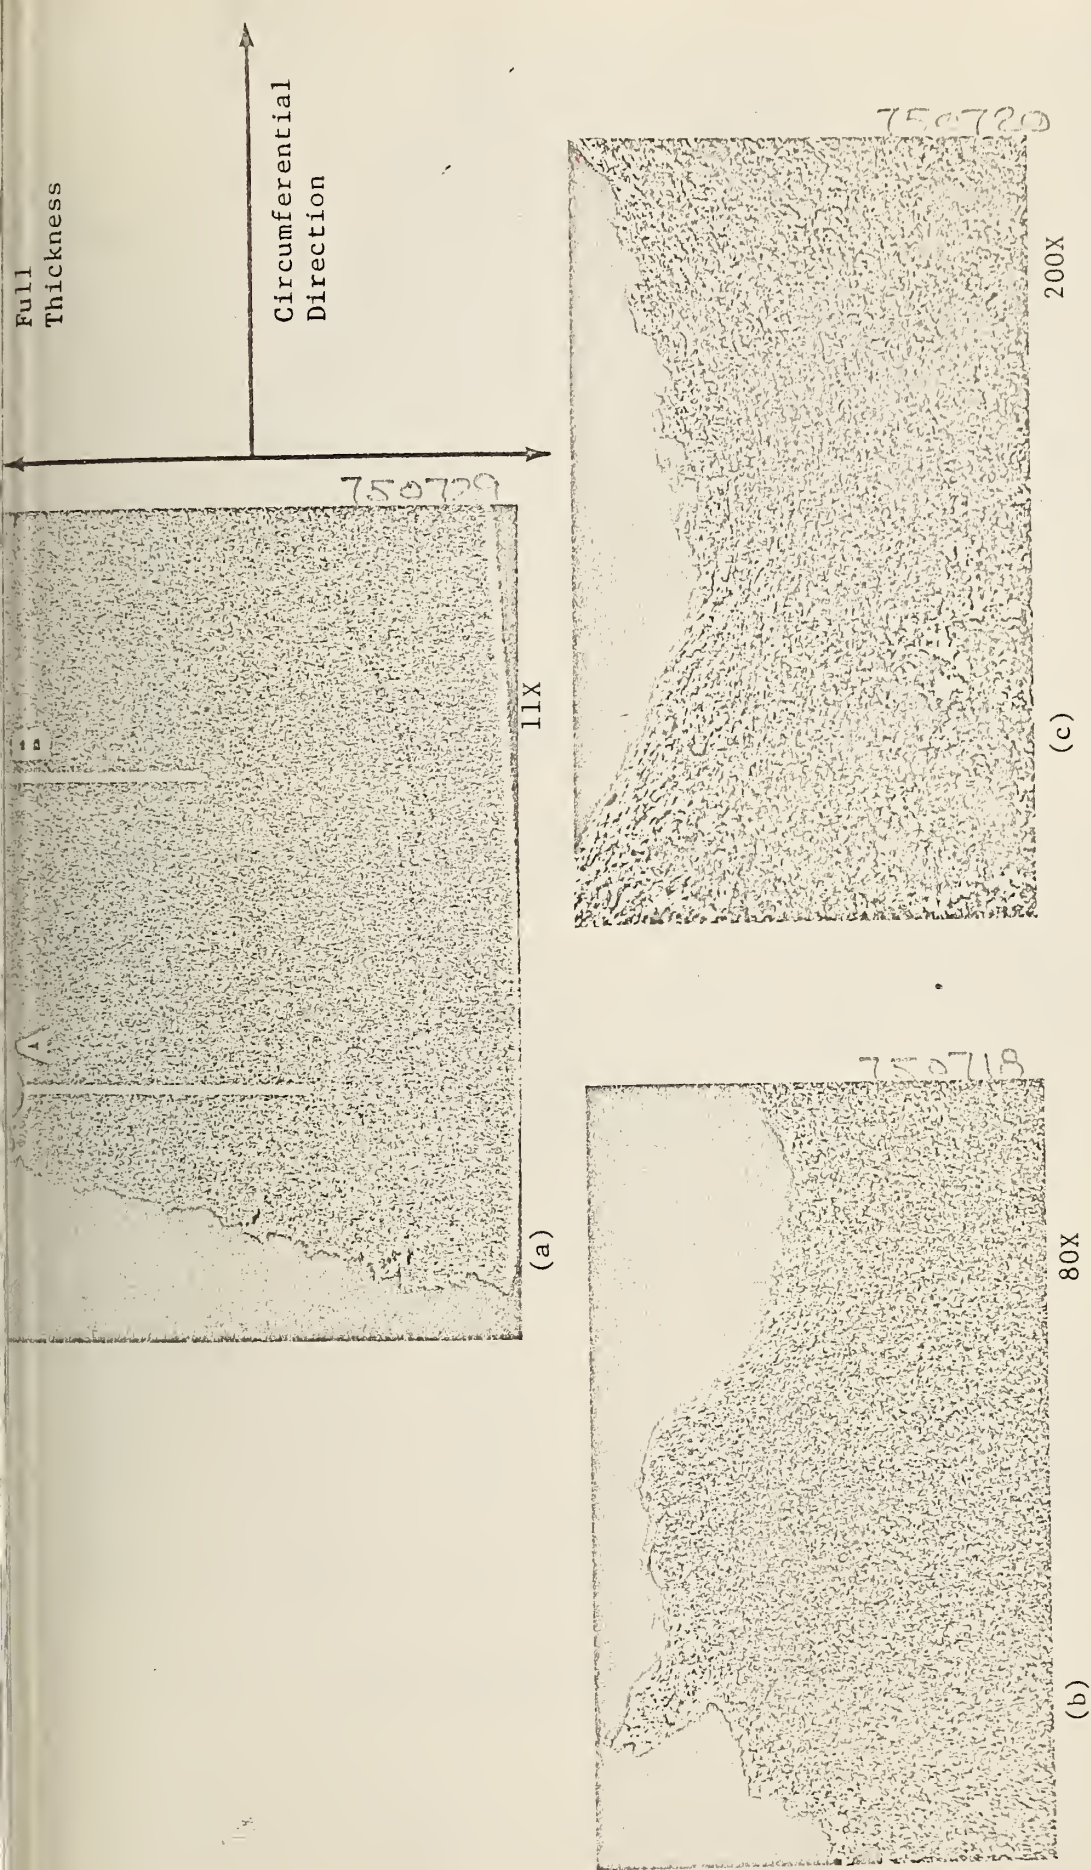
Figure 8 shows the fracture profile at Specimen IV. A gouge near the fracture surface is evident in Figure 8a. The gouge is about 0.02-inches deep. Flowed metal beneath the gouge can be seen in Figures 8b and 8c. The most severely flowed metal seems to penetrate about 0.0006-inches below the bottom of the gouge. Away from the flowed metal, the microstructure has the usual appearance of a quenched and tempered steel. These observations --- a gouge, flowed metal beneath the gouge, and a typical quenched and tempered microstructure --- were found in Specimens II and III, also, indicating a reasonably uniform disturbance throughout the region shown in Figure 7. A crack in the bottom of the gouge was detected in the fracture profile of Specimen II, as shown in Figure 9.

In Figure 8, evidence of a 0.02-inch deep gouge and evidence of flowed metal beneath the gouge was shown for the fracture profile of Specimen IV. Two Knoop microhardness traverses were made on this metallographic specimen, along the lines labeled A and B in Figure 8a. The purpose of making these hardness measurements was to search for evidence of strain hardened metal beneath the gouge. To facilitate accurate measurement, hardness was measured using the Knoop microhardness technique. The range of Knoop hardness numbers measured, 257 to 313, corresponds roughly to Rockwell hardness numbers on the C-scale of 21 to 30.

Figure 8. Fracture profile at region labeled IV in Figure 7. (a) Gouge in outside wall at fracture profile. (b) and (c) Evidence of flowed metal beneath gouge. Lines in Figure (a) show approximate paths for microhardness measurements reported in section 5.3.

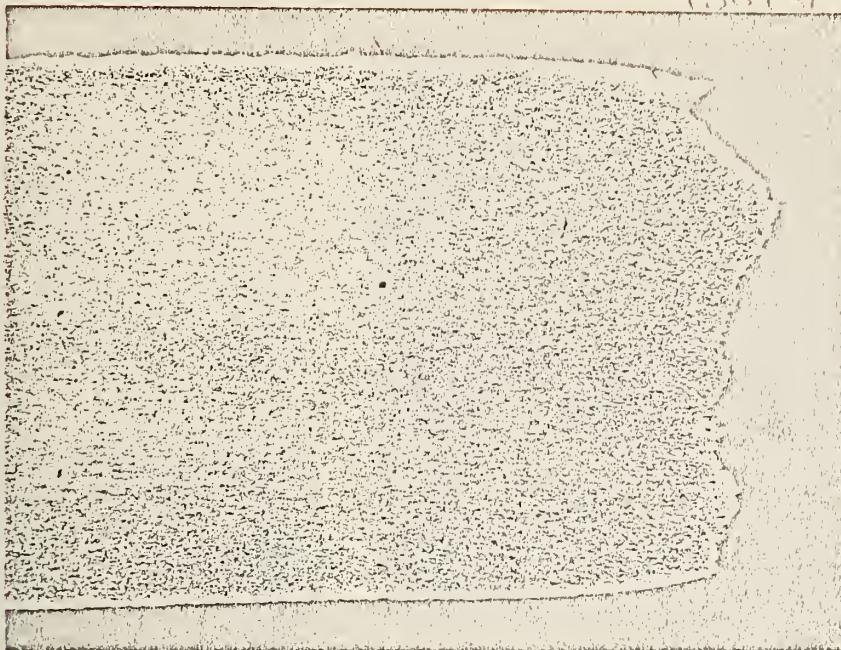
Incidental to the observation of the fracture profile is the observation of a decarburized layer along the inside cylinder wall. The layer shows up as the white region along the inside wall in Figures 8 and 12. Specimens I, II, III and IV each showed evidence of decarburization --- the layer was about 0.002 to 0.004 inches deep. This decarburized layer does not seem to be related to the fracture of the gas cylinder.

Figure 12. Fracture profile of Specimen I in Figure 7 showing wall thinning near the fracture surface. X 10

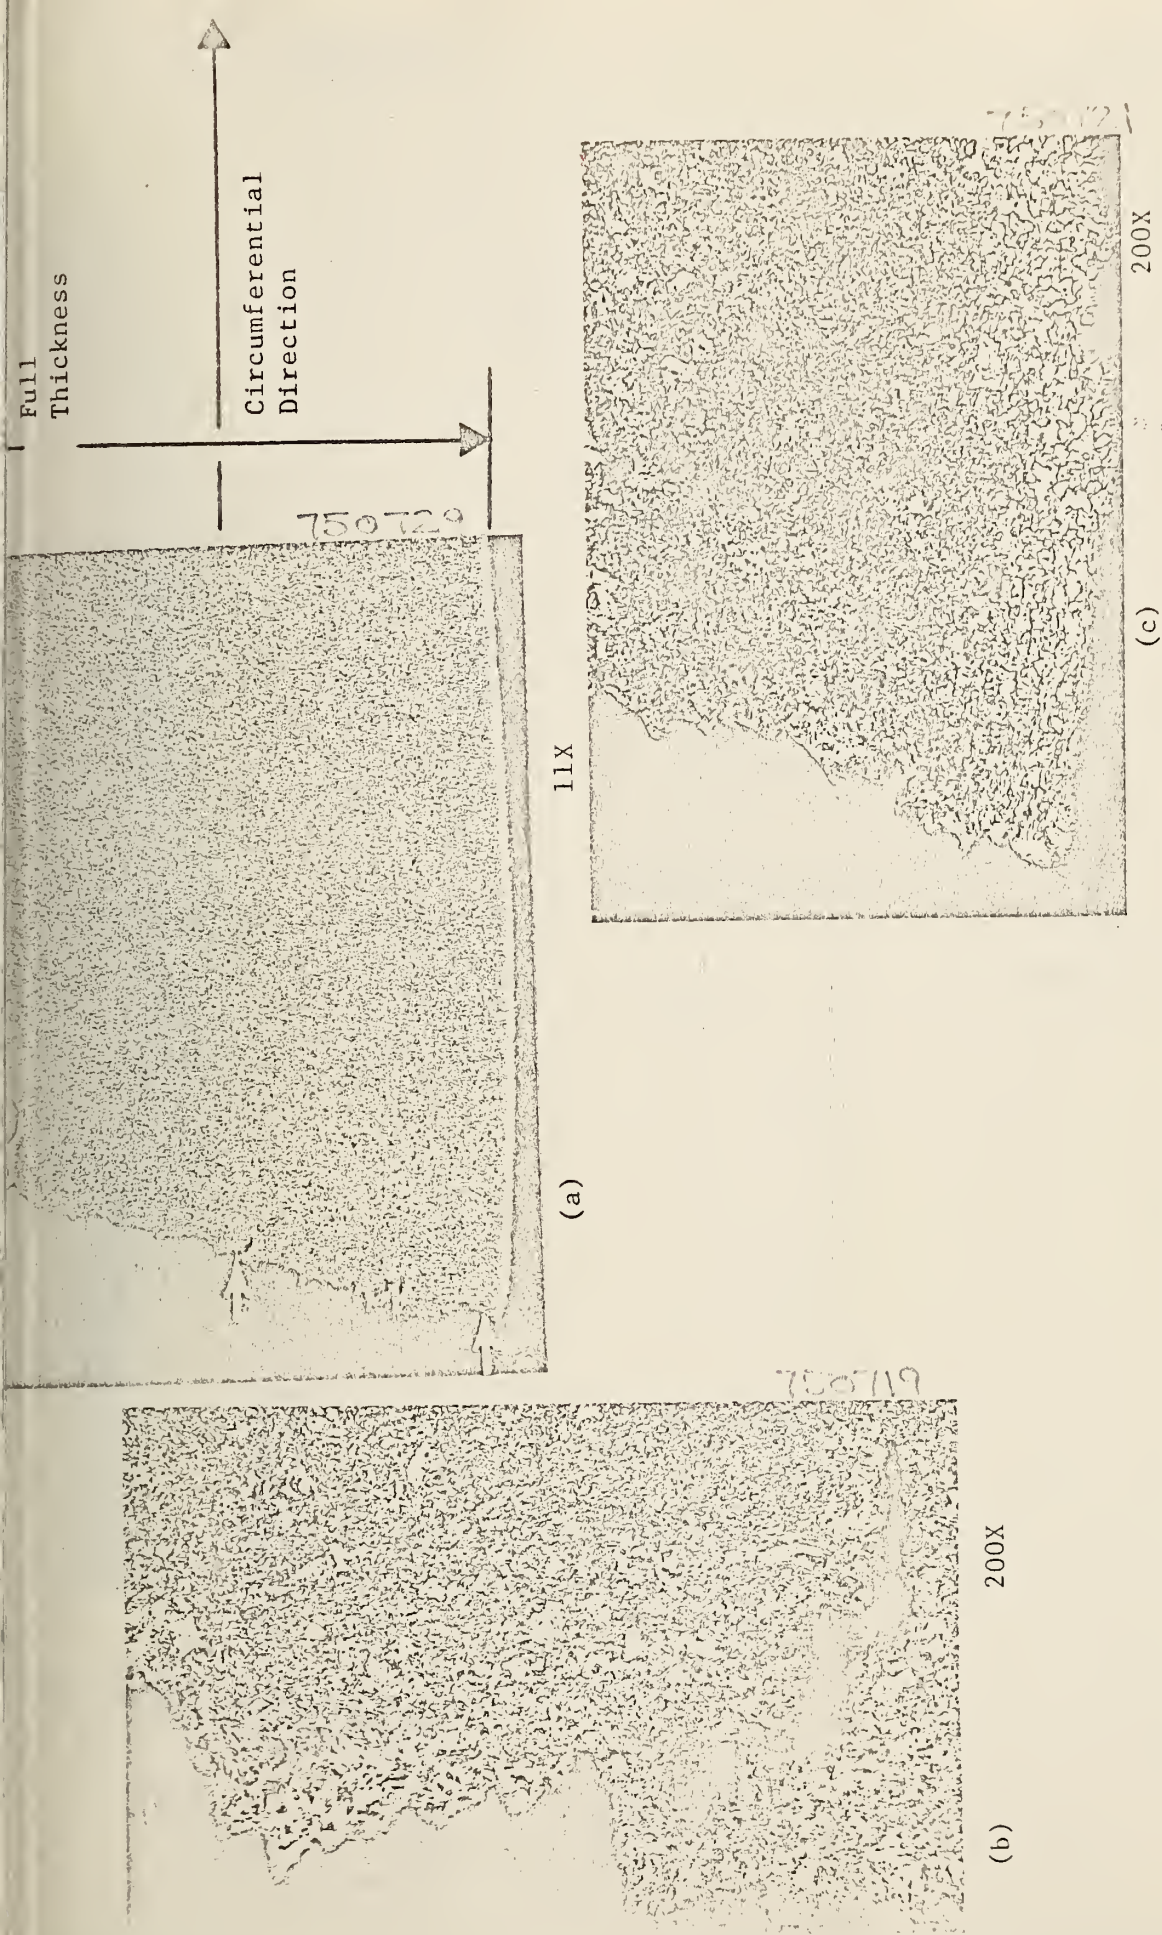
Figure 14a shows the full thickness fracture profile of Specimen IV. Figures 14b and 14c are close-ups of the regions indicated by the upper and lower arrows, respectively, in Figure 14a. In general, the fracture profile near the upper arrow showed rounded recesses and rounded dimples, which were coated with corrosion product. In the region indicated by the lower arrow, the fracture profile showed sharp recesses and pointed dimples. Similar observations were made on the full thickness fracture profiles of Specimens II and III. These results support the view that a part-through crack existed at the fracture origin. Evidently, the part-through crack had been exposed to a corrosive medium, but it is not possible to establish the time of exposure accurately.

voids which have linked up appear next to the fracture profile in Figure 14b. The orientation of these voids suggests that they formed where inclusions of the type shown on face C of Figure 15 (See Section 5.2.1) separated from the steel matrix. The corrosion product in the voids, and also the rounded contours of the voids, suggest that they were connected to the fracture surface. The connection is not evident in Figure 14b, probably because of the way the metallographic section was cut. Perhaps these and other voids formed in response to local stresses which caused some shape distortion when the part-through crack formed.

Figure 14. Fracture profile of Specimen IV in Figure 7. (a) Full-thickness profile. (b) Corrosion product and rounded recesses in rusty and discolored region of fracture origin. (c) Sharp recesses and pointed dimples in the bright region along the inside wall below the fracture origin.

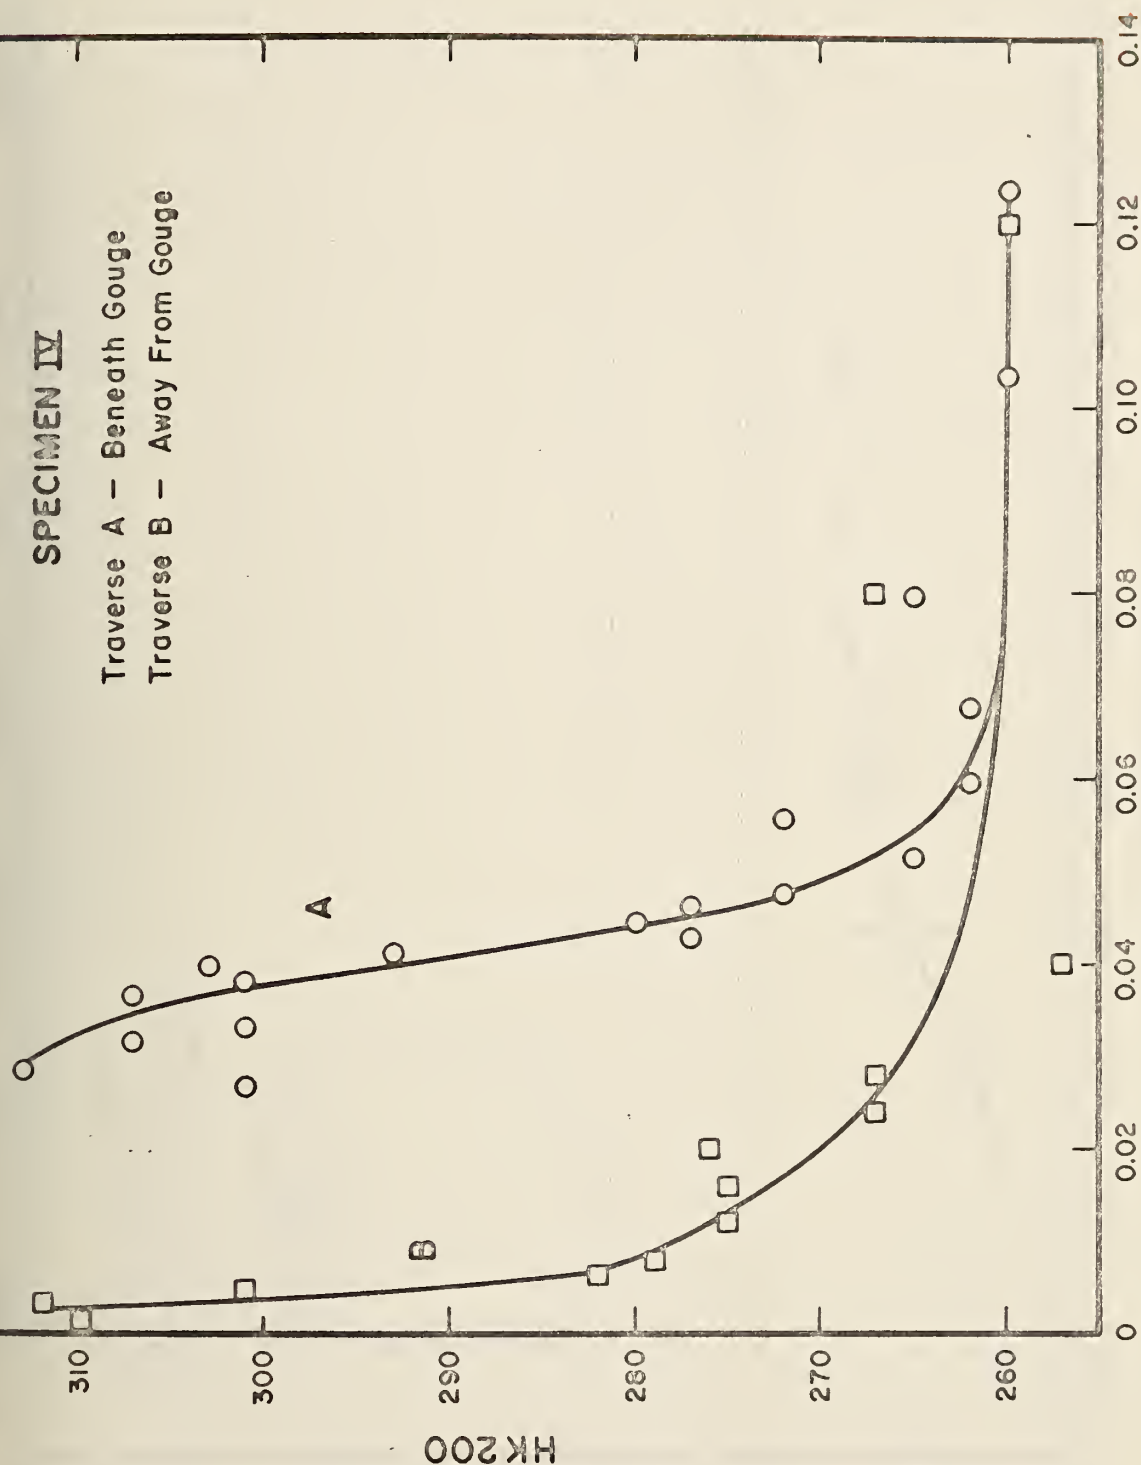
Figure 16. Knoop hardness vs. distance below surface for the fracture profile of Specimen IV in Figure 7.

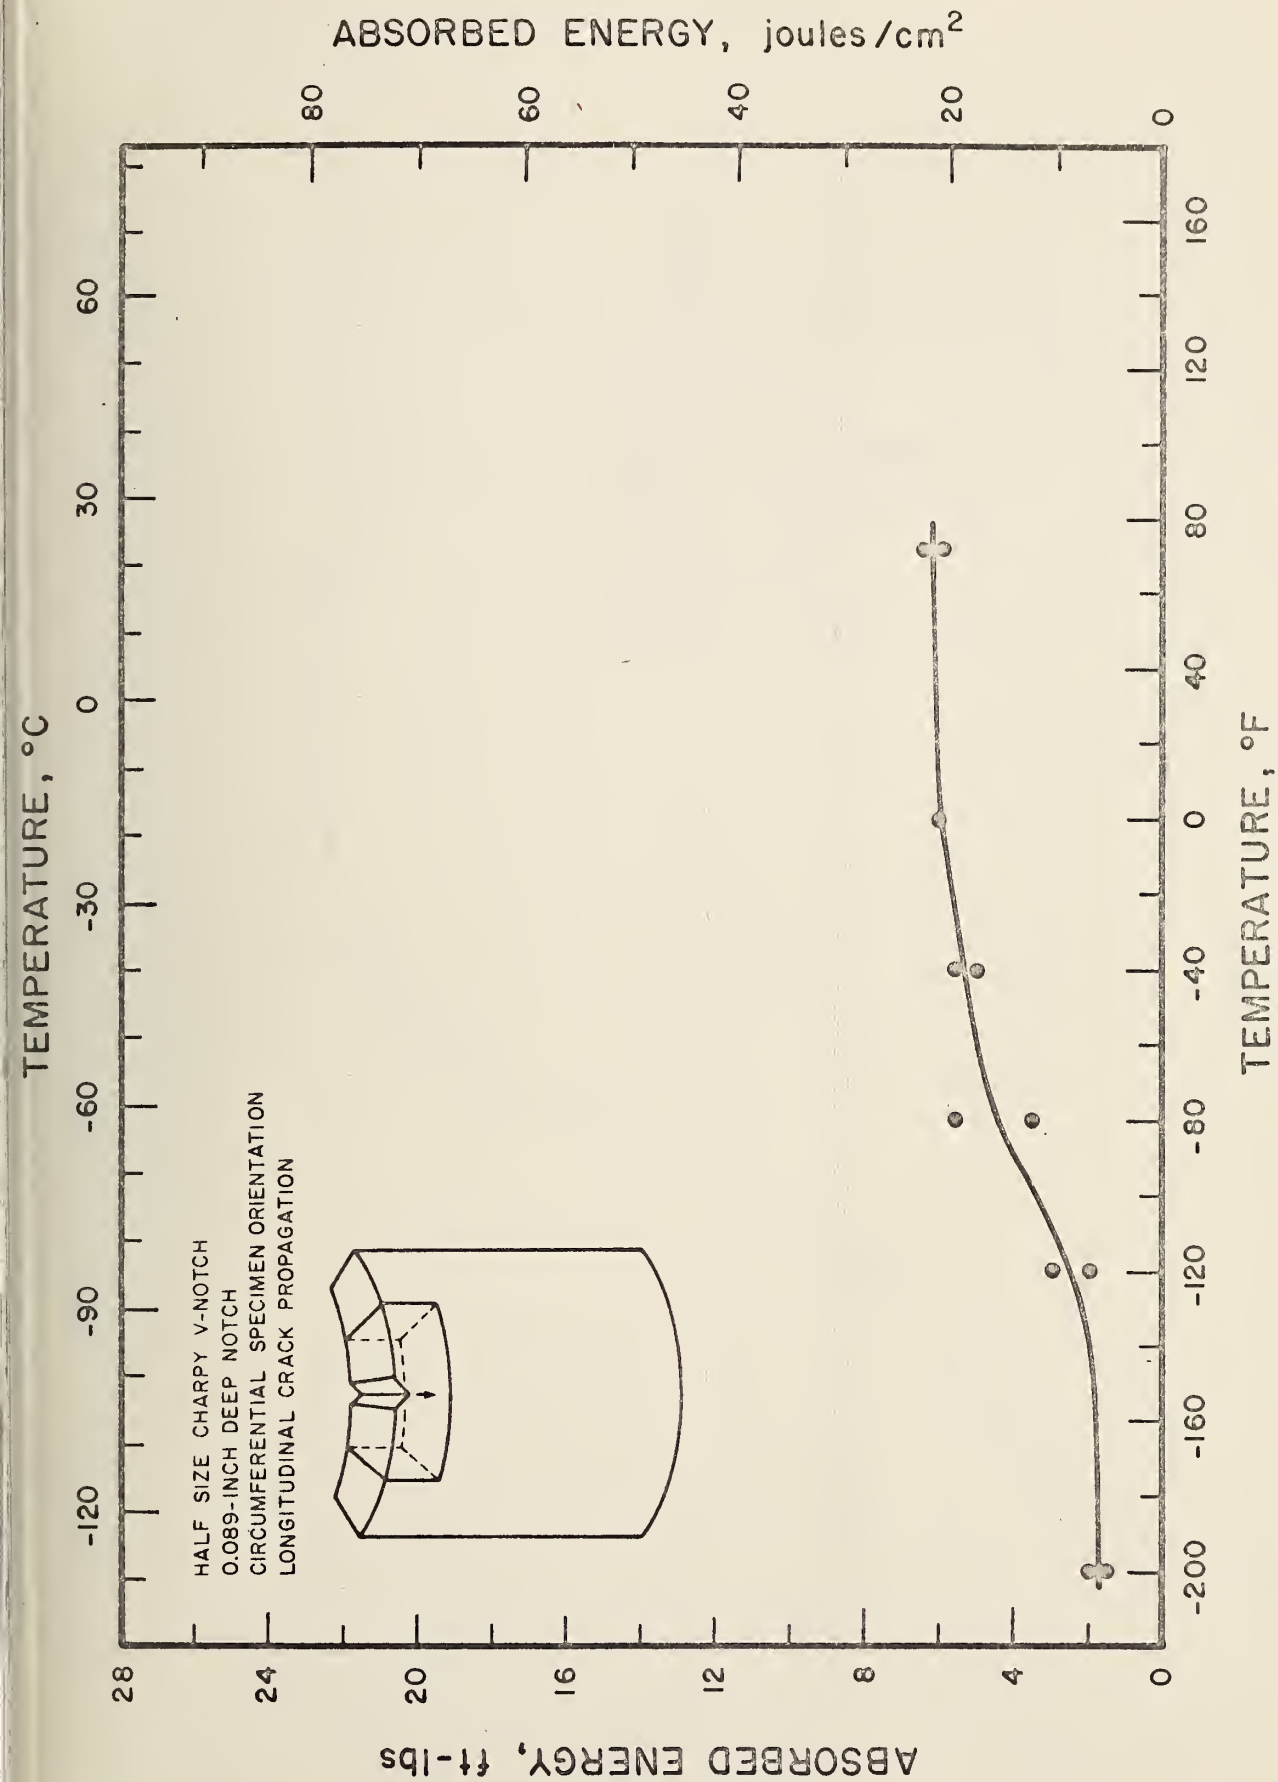
Results in Figures 17 and 18 show a transition from higher to lower values of toughness, starting at about -40°F. At and above 0°F, these results show that there is less resistance to longitudinal crack propagation than to circumferential crack propagation. The absorbed energy data show an increase in resistance by a factor of 3.6, and the lateral expansion data show an increase in resistance by a factor of 3.3. Hence, the manner in which gas cylinder T-0967 failed --- three full-length longitudinal tears --- is consistent with these results. As noted in Section 5.2.1, the primary reason for longitudinal crack propagation in a cylindrical pressure vessel is the fact that the hoop stress is twice as large as the axial stress.

Figure 17a. Absorbed energy versus temperature for longitudinal crack propagation.

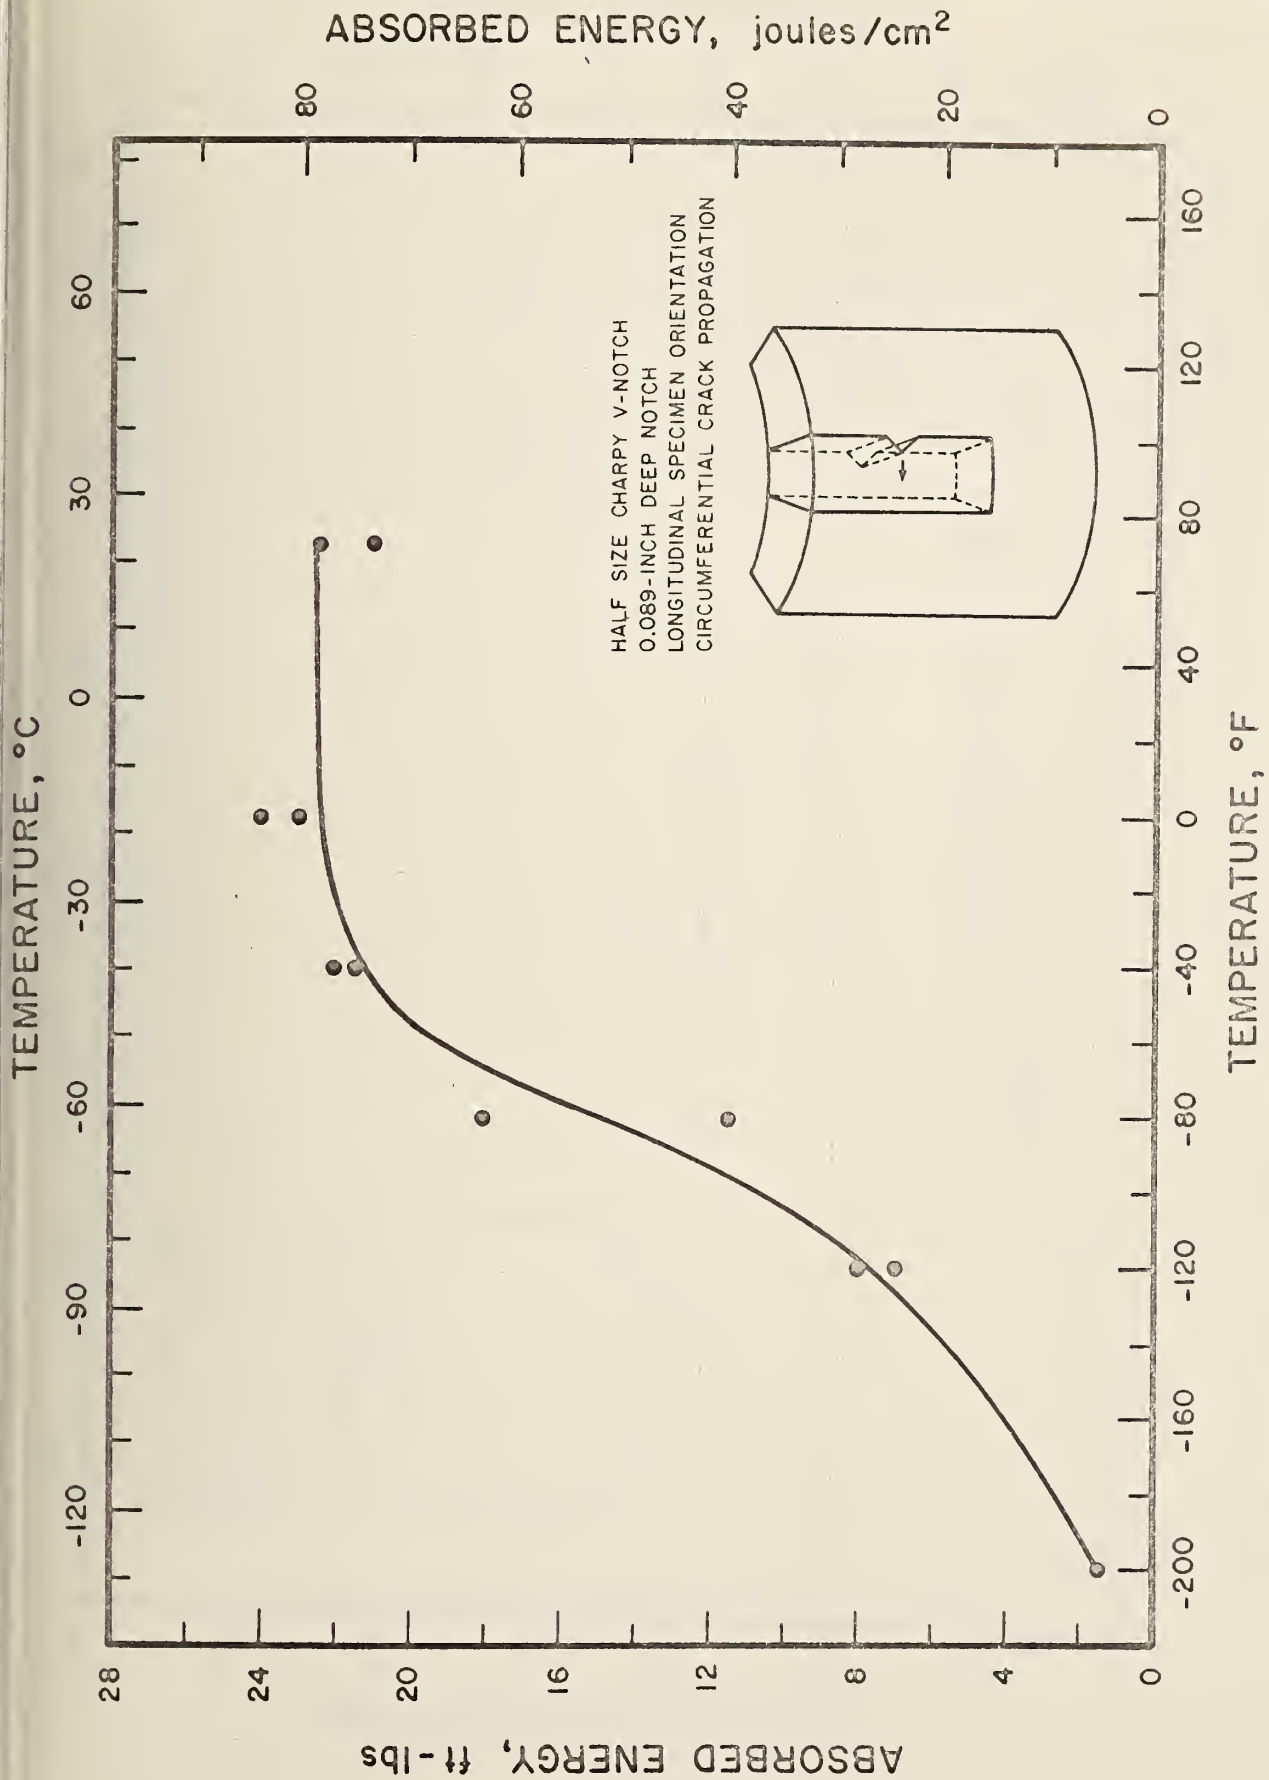
Figure 17b. Absorbed energy versus temperature for circumferential crack propagation.
